**2015 Annual Groundwater
Monitoring Report**

Palermo Wellfield Superfund Site
Tumwater, Washington

for
**Washington State Department of
Transportation**

April 7, 2017

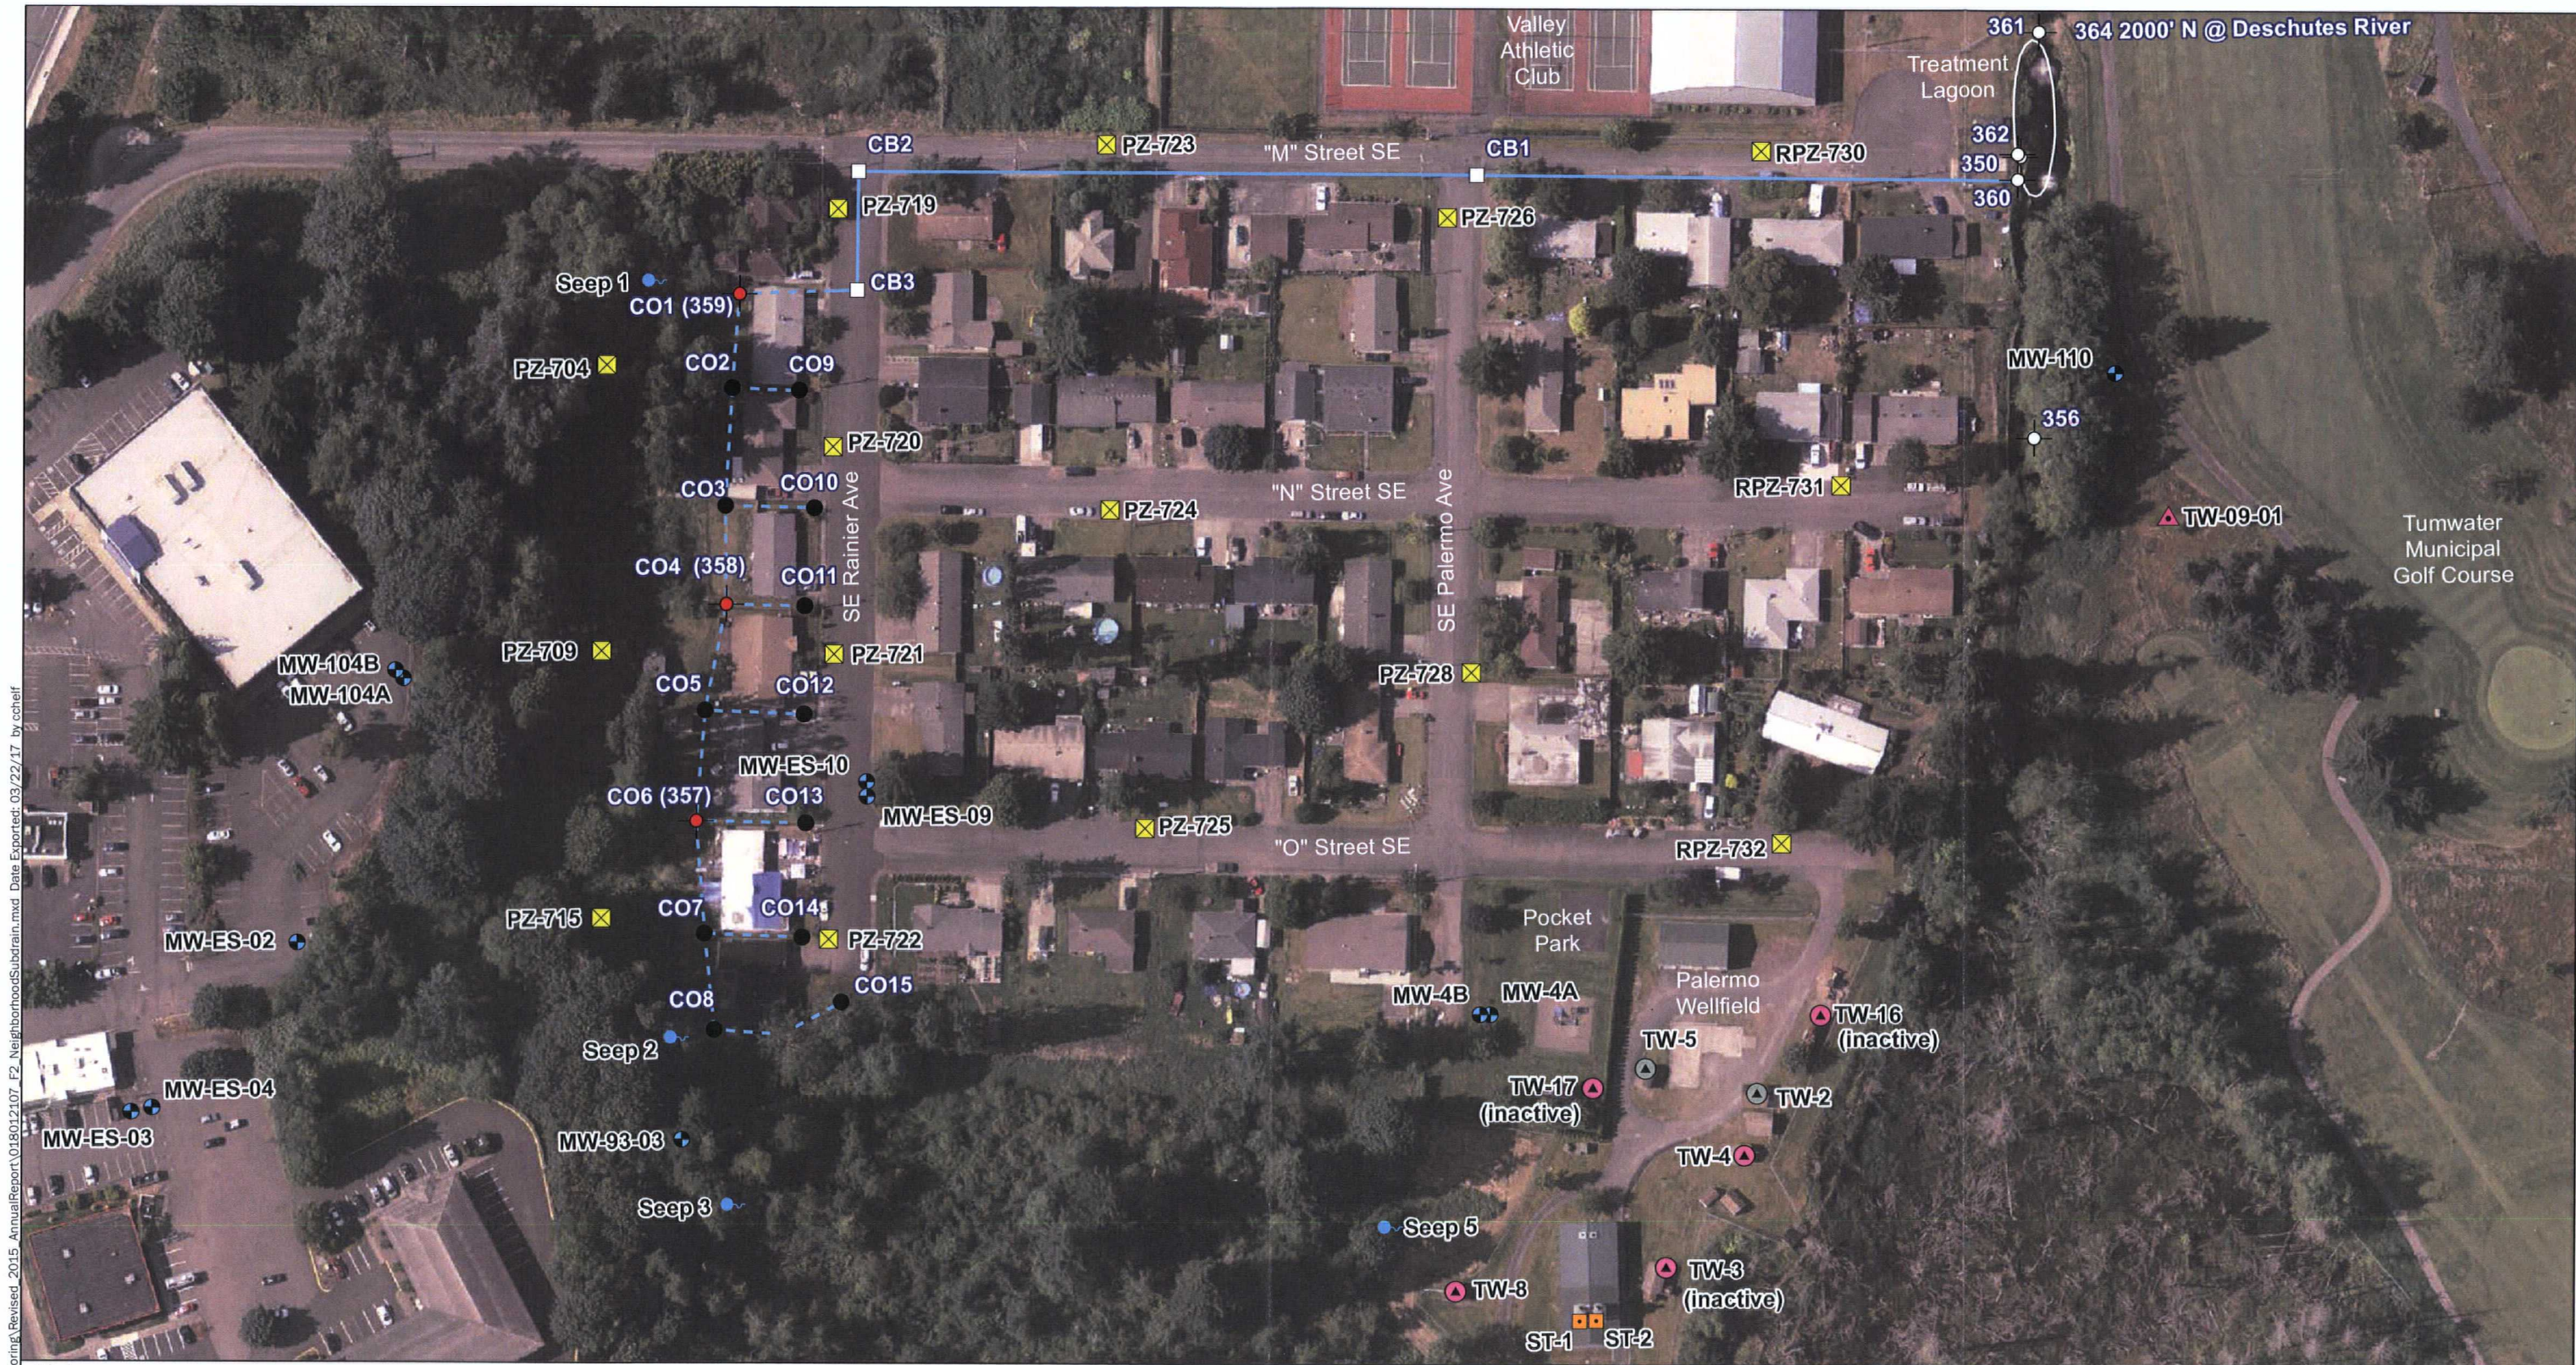
Figure 2

1. The locations of all features shown are approximate.
2. This drawing is for information purposes. It is intended to assist in showing features discussed in an attached document. GeoEngineers, Inc. cannot guarantee the accuracy and content of electronic files. The master file is stored by GeoEngineers, Inc. and will serve as the official record of this communication.
3. TW-3, TW-16, and TW-17 are installed but not operating.

A subdrain system and treatment lagoon were constructed in 2000 within the Neighborhood. The purpose of the subdrain system is to lower the local groundwater table beneath homes west of SE Rainier Avenue and remove PCE and TCE from the collected water (Figure 2). The subdrain system includes a subgrade

perforated piping network installed behind the seven southern-most houses west of SE Rainier Avenue. The main perforated pipe or “trunk drain” is beneath the backyards of the houses. Groundwater that enters the perforated pipe flows to an unperforated “tightline” pipe beneath SE Rainier Avenue and M Street SE. The tightline pipe drains to a treatment lagoon located at the Municipal Golf Course. PCE and TCE are removed from the water by surface aeration before being discharged to the Deschutes River by way of an existing water course.

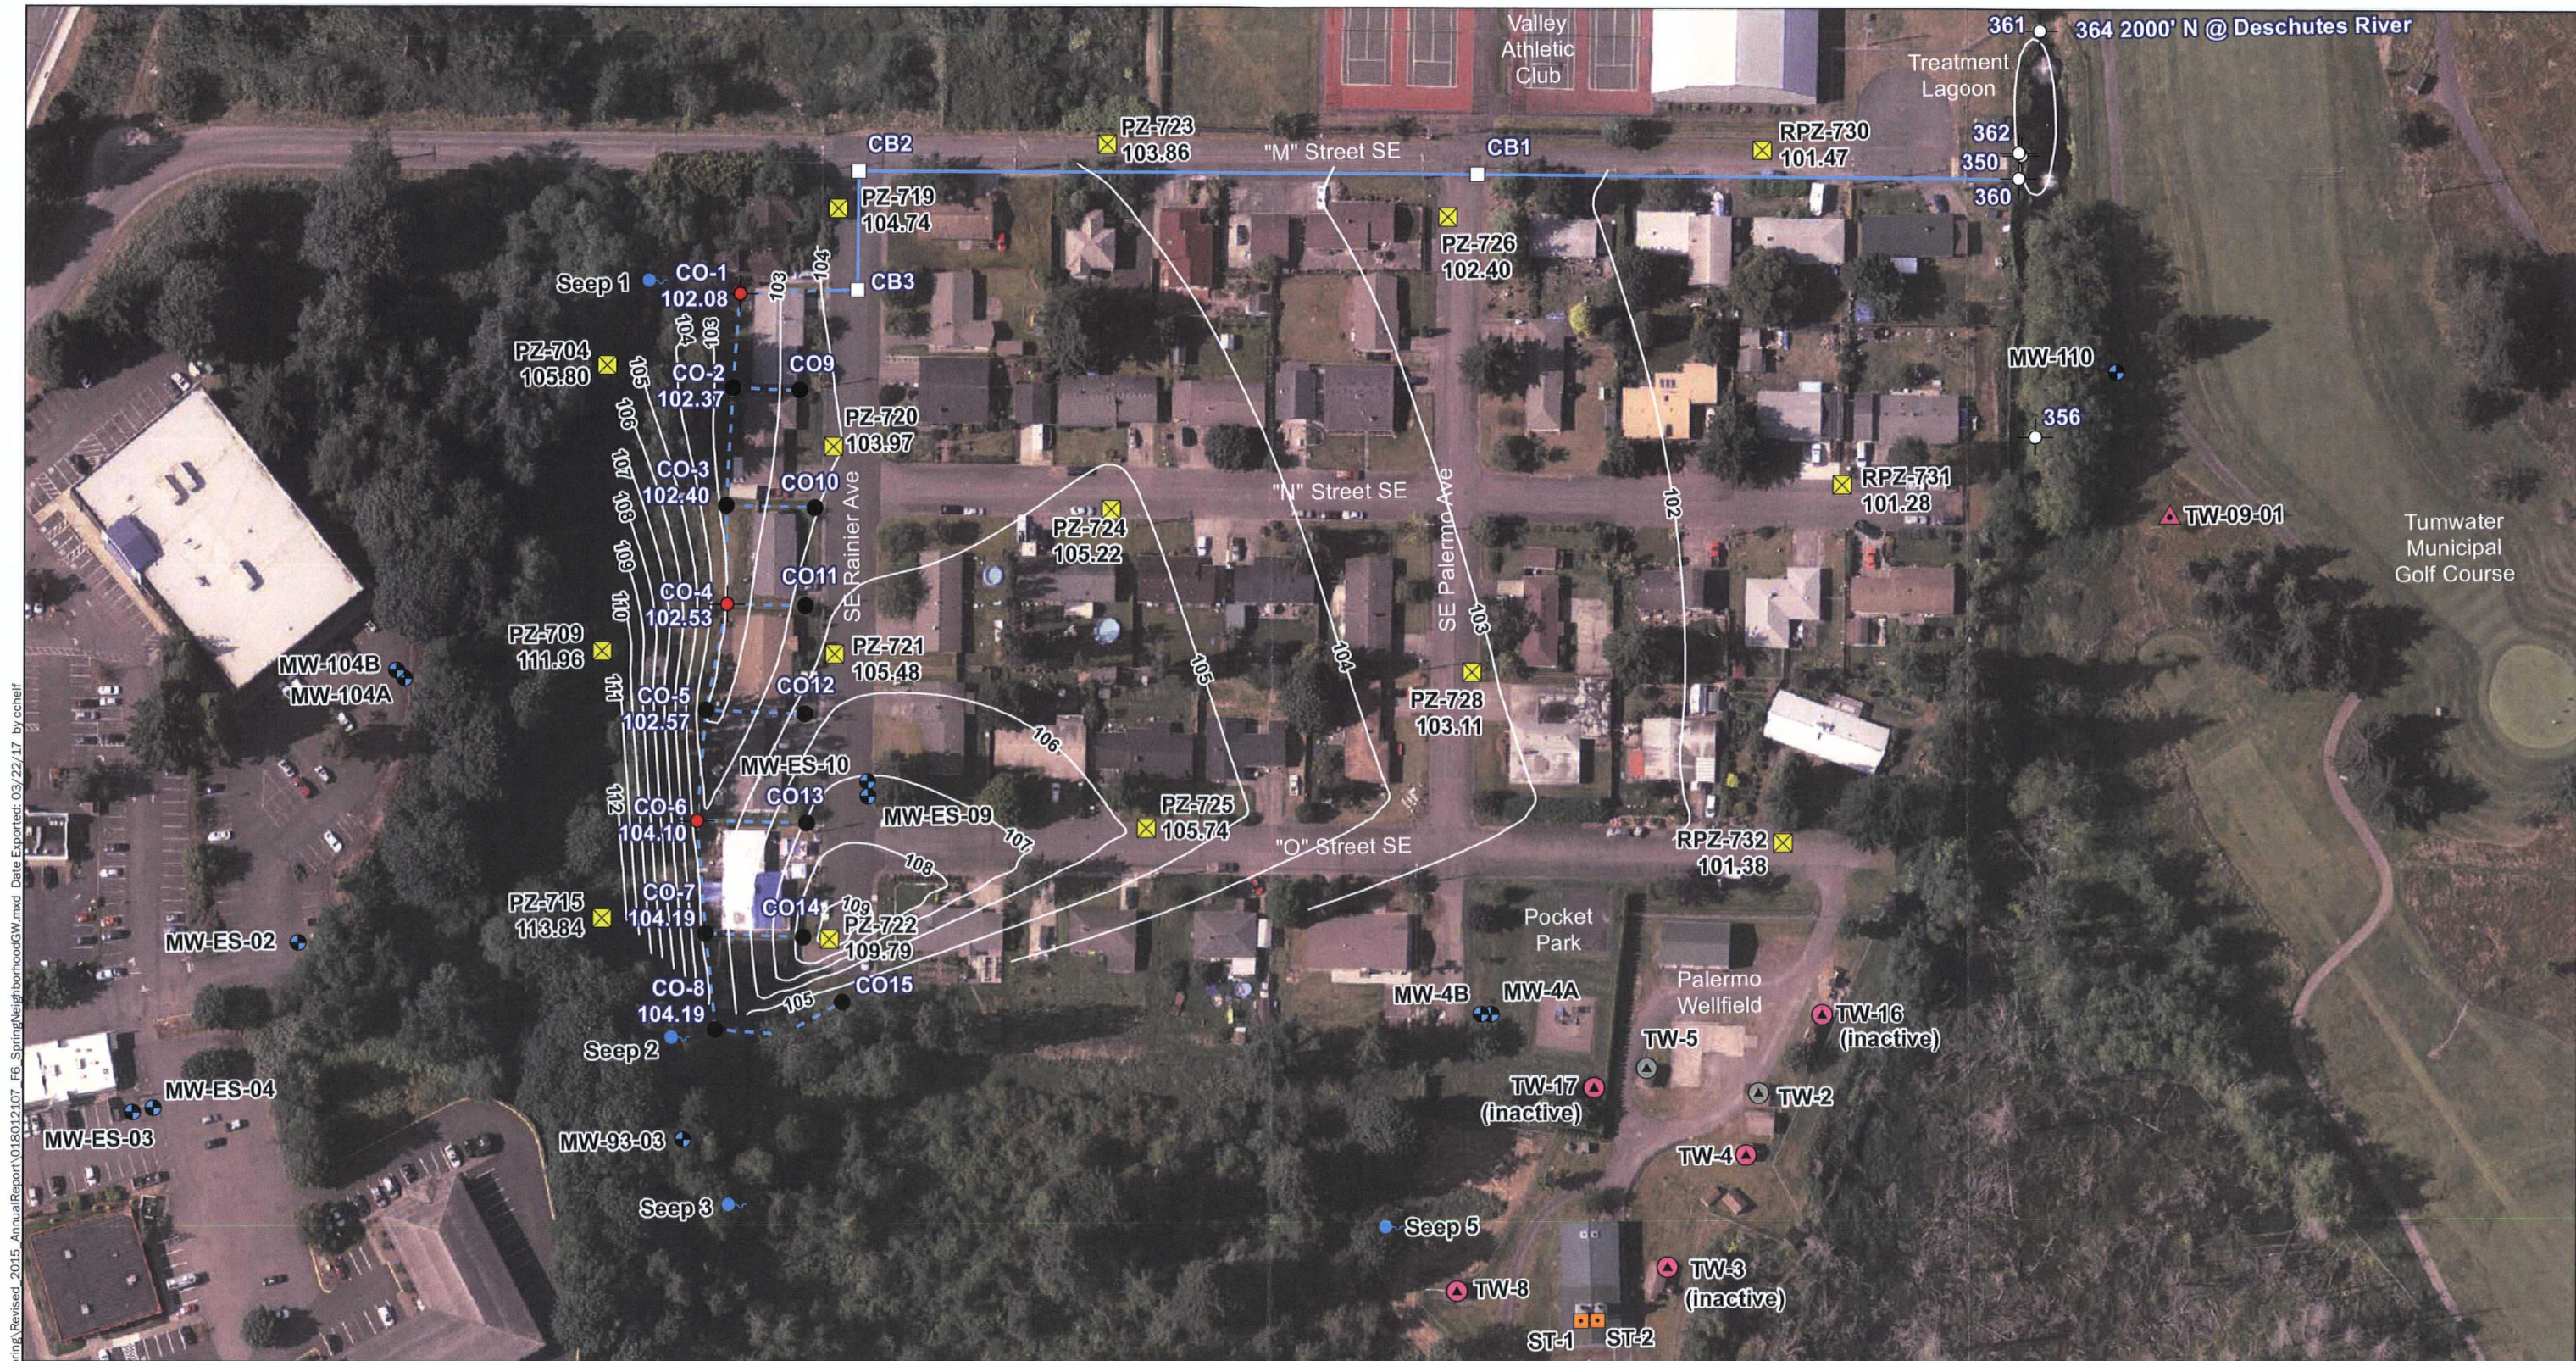
Figure 6

1. Contours were generated using Surfer 8.0 (Golden Software) contouring software using the natural neighbor gridding method from water levels measured on March 9th and 18th, 2015.

**Spring 2015 - Palermo Neighborhood
Shallow Groundwater Elevations**
